PREDICTION OF FRACTURING AND DYNAMIC FAILURE OF THE ROOF IN TABULAR STOPES IN A PLATINUM MINE

Submitted by:

Professor T R Stacey, School of Mining Engineering, University of the Witwatersrand
C van Rooyen, Lonmin Platinum

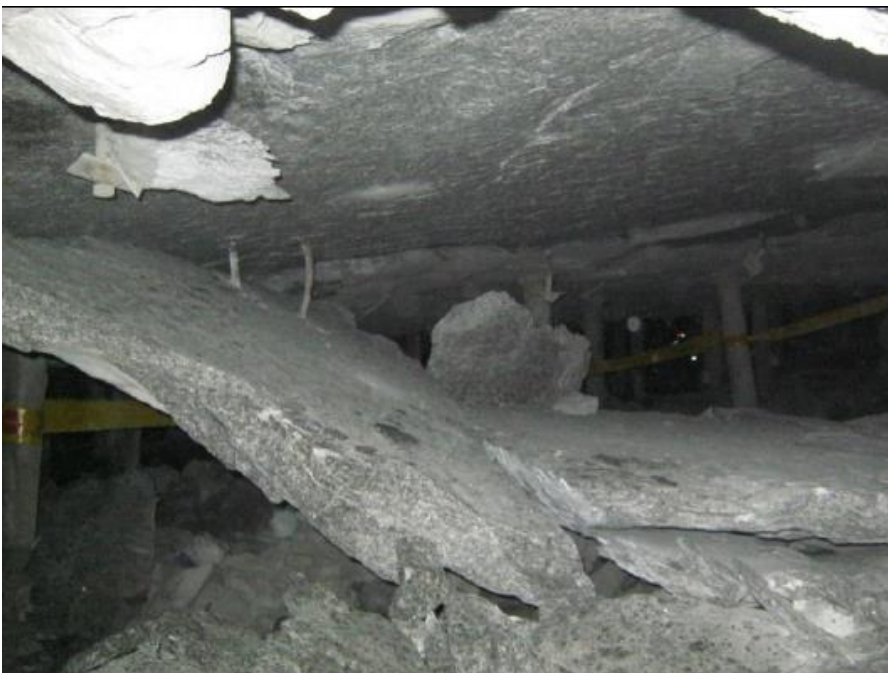
Roof falls have occurred, which indicate the effects of stress. The photograph below shows one such fall, illustrating the formation of flat fracture planes and slabs, which are frequently observed.

The development of fracturing in the stope roof has been detected using micro-seismic monitoring stations and has shown an uncommon degree of activity for such mines. It appears that fracture growth is occurring, resulting in the formation of incipient slabs. Suspected dynamic failure has occurred on several occasions, over a typical area of more than 400m², destroying the supports in the stopes. The observed height of the collapsed rock into the roof is about 1.5-2m. It is surmised that the perceived dynamic failures are ultimately due to violent buckling of the hangingwall “plate”, but this is only opinion.

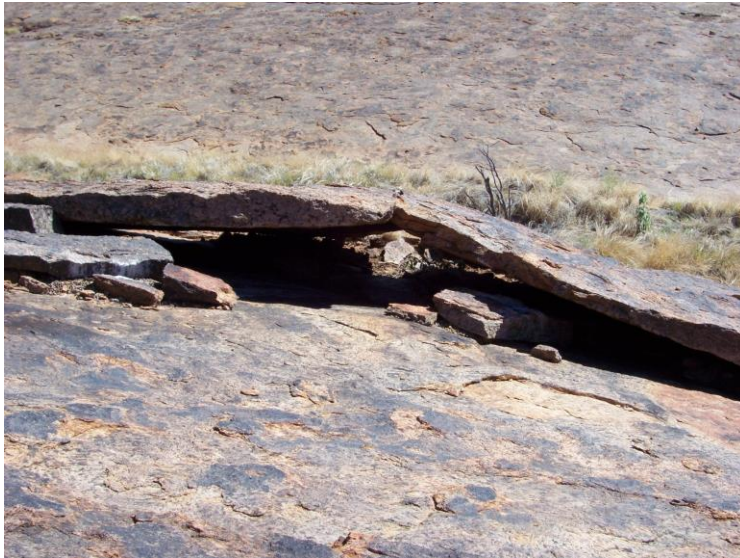
The underground slabbing is visually similar to exfoliation behaviour that can be observed on rock outcrops, as illustrated below.

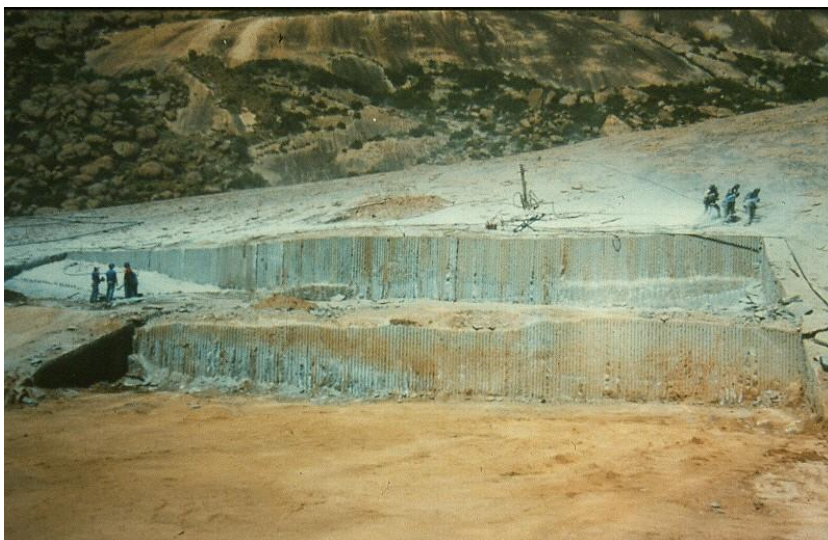
A further practical example of such slabbing behavior was observed in a small granite dimension stone quarry, illustrated below.

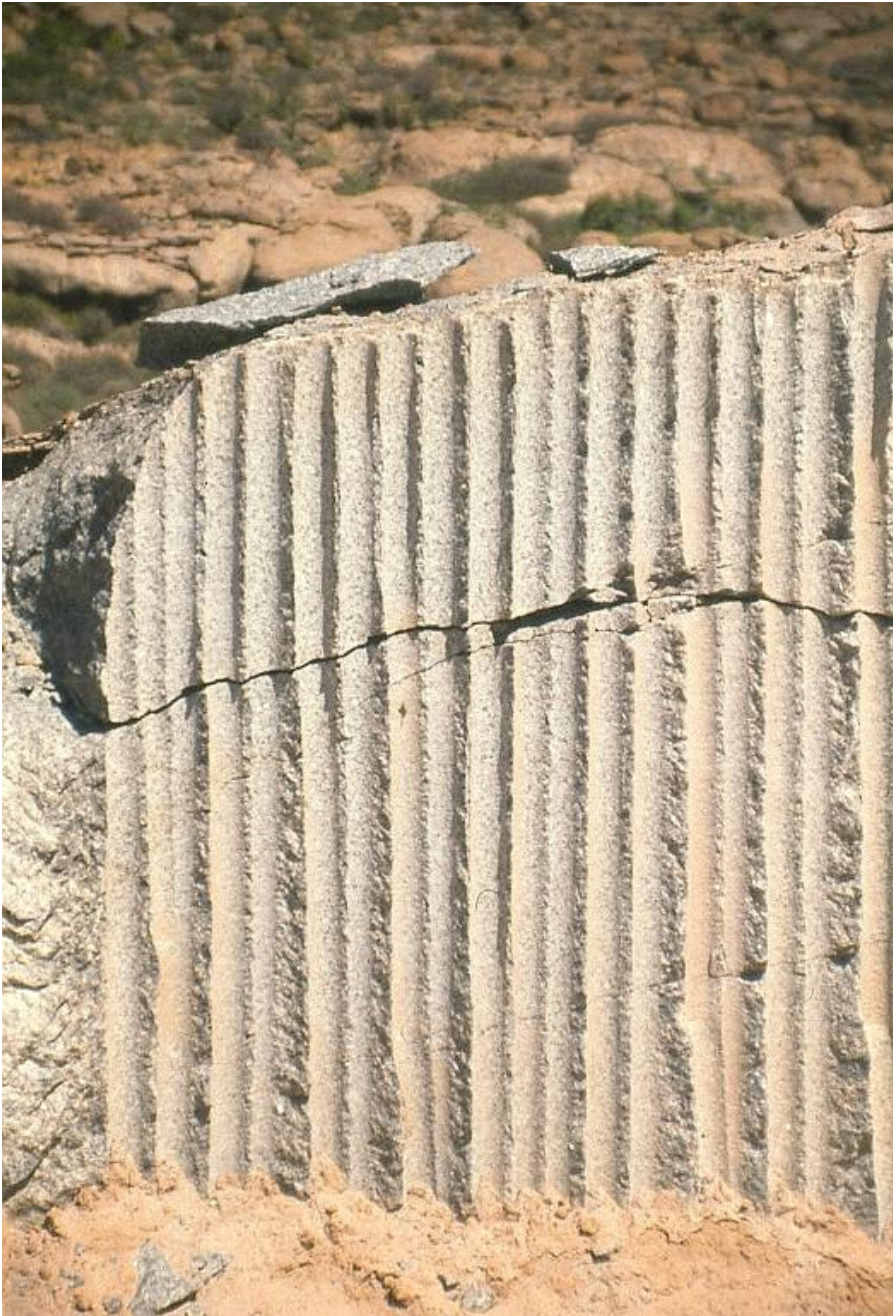
During the drilling of the closely-spaced vertical holes, which can be clearly seen in the photograph below, a fracture developed sub-parallel to the surface. These fractures tended to occur violently and in one case it was reported that a drill was “ejected” about 3m into the air.

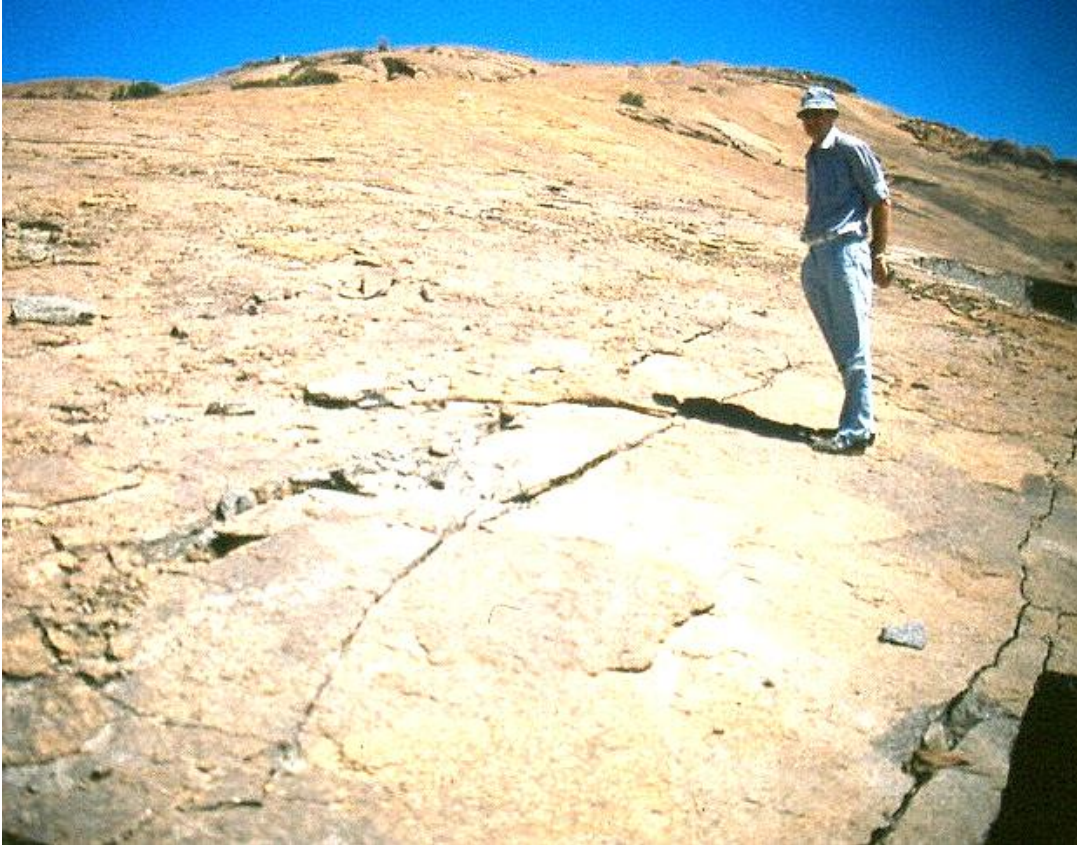
After the vertical face of the quarry was created, sub-vertical fractures also developed parallel to this face, which can be seen in the photograph below.
